Over the past several months Hot Tub Updates have been provided in the Building Managements report as an attachment with the strata council meeting minutes. Below is a summary as well as the latest findings.

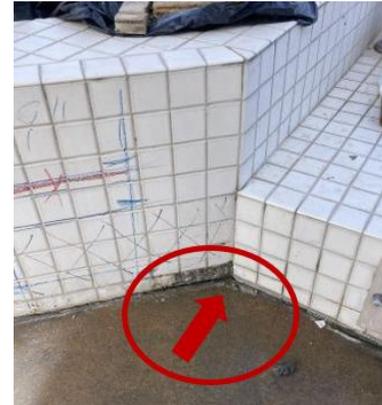
A leak was identified in the winter of 2025, and an initial investigation revealed a leak when the jets on the hot tub were turned on. Our pool contractor used a camera to further investigate and identified cracks in several jets due to Teflon tape used which expands and can crack fittings. Additional leaks were identified in the drain, and our contractor was able to fix some leaks and stated he would use a stop leak (a commercial product) that he has used with success in the past. This process was done when the temperature improved last spring. After the product was applied and setup the jets were re-tested with no leaks, but a large leak persisted near the pool deck as shown (red arrow).

It was recommended that the top of the concrete area above the jets be cut open to investigate. Issues with getting the location of the leak pinpointed and what is required to repair were as follows:

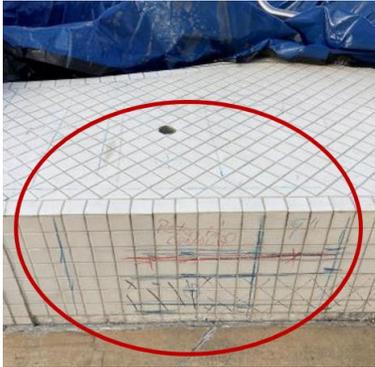
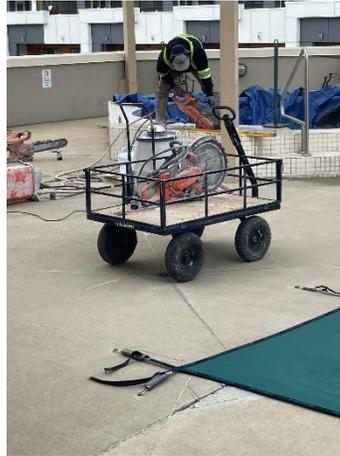
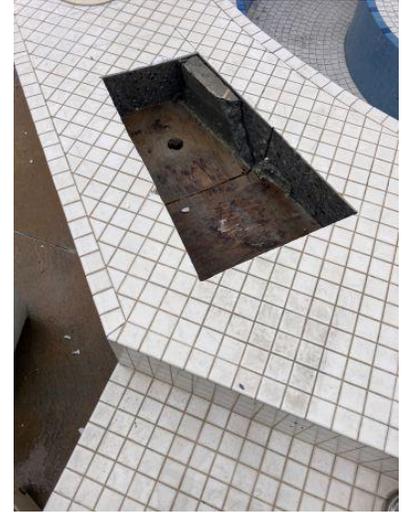
5. In the meantime, our pool contractor was able to get a radar scan done on the upright hot tub wall and we opened the top section of the double wall up to see if we could find a leak or check to see how the lines were run, or how the walls were constructed.

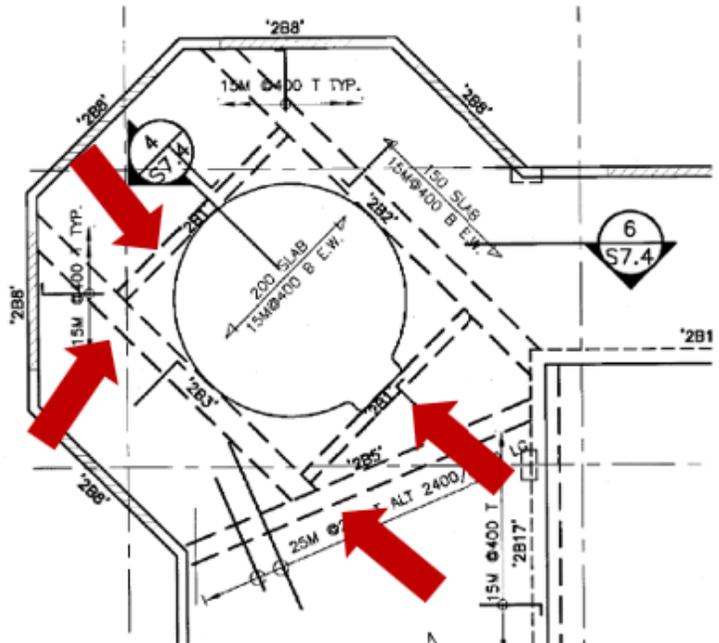
6. Once KO Structural reviewed the drawings and another site visit they required a scan report to be done to determine where the support beams were and the size of the beams, and rebar in the concrete.

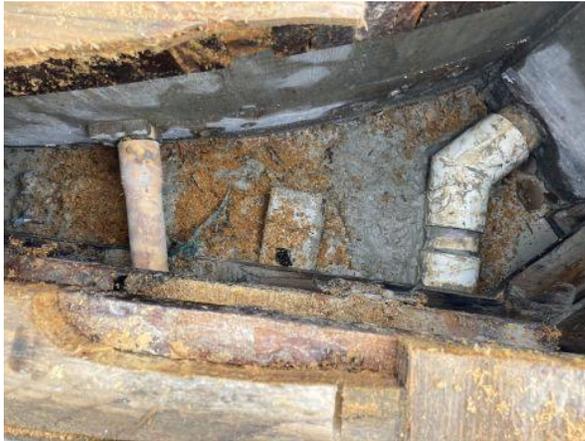
7. Our pool contractor with the top section open has located two lines, one line is the scrubber line which when tested did not leak, There was also one jet line in the cavity but it was in concrete, and when the jets are turned on it sprays water out the side of the hot tub bottom step (but not from the visible line).

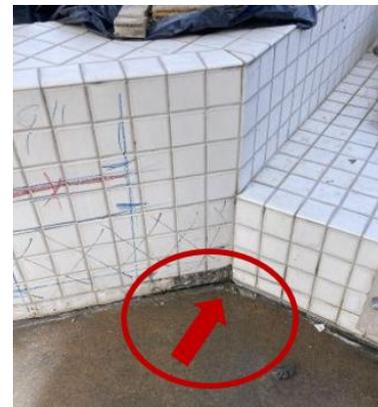
8. Our pool contractor cut the jet line and used a scope camera to try locating the leak with the amount of cable he ran out it appears the cracked line may be slightly below the structural suspended concrete deck which the structural engineer will not allow cuts in the deck. A further challenge is the bottom of our hot tub is concealed in the ceiling of a commercial tenant and not visible.
9. On the advice of our structural engineer, our pool contractor is currently working to get a more in-depth radar scan done to accurately locate the structural beams supporting the hot tub The structural engineer to review and guide strata on the next steps as to how we can access the problematic pipe that is below the structural slab somewhere to the left of the red arrow.

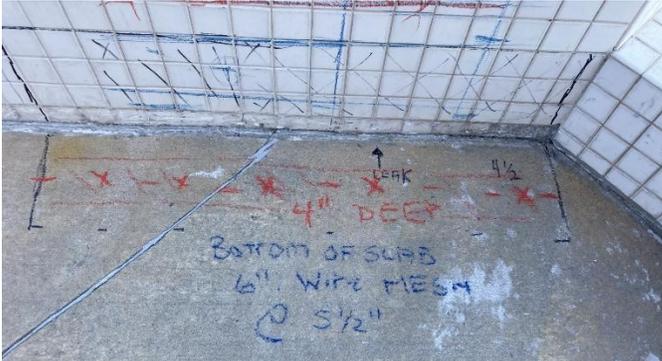
10. Precision Rabar Scan was on site today and scanned the area our engineer (KO Structural Engineer) and our pool contractor (Poolman - All Service Properties) requested. As Poolman used a scope camera and noted the pipe with the leak is 4 ½" below the pool deck.

Precision Rabar scan revealed there is a 6" reinforced slab with welded wire mesh about 5 ½" below the slab. This concrete rests directly on the 10" reinforced 2-way suspended slab supported by concrete beams. A scan report was received from Precision Radar Scanning, and he made notes directly on the slab near the leak as shown below.

Our pool contractor (Poolman) has been contacted to connect with Precision to cut open the slab area to expose the leak.
