Hot Tub at Centuria Urban Village developed a leak. The Hot Tub was immediately closed and below is a summary as well as the latest findings as we have worked on a fix. A summary of events in a timeline format is presented below.

**Timeline Summary:**

**Hot Tub Repair Cost / Budget:**

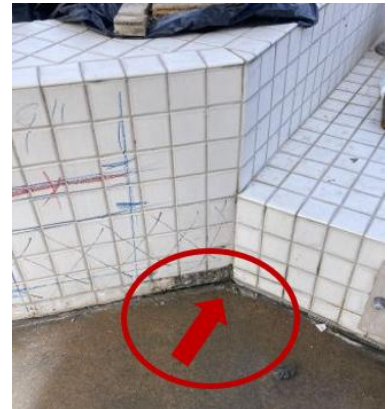
After the leak seal product was applied and adequate time to setup the jets were re-tested, but a large leak persisted near the pool deck as shown above (red arrow).

It was recommended that the top of the concrete area above the jets be cut open to investigate. Issues with getting the location of the leak pinpointed and what is required to repair were as follows:

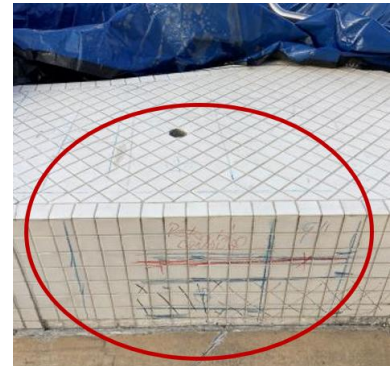
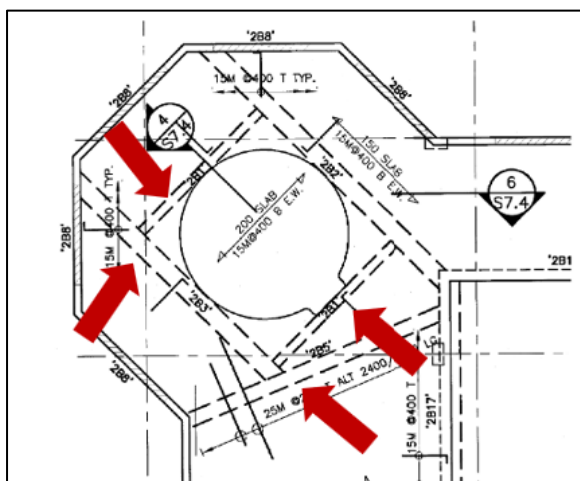
Once KO Structural reviewed the drawings and another site visit they required a scan report to be done to determine where the support beams where and the size of the beams, and rebar in the concrete as shown in the diagram below.

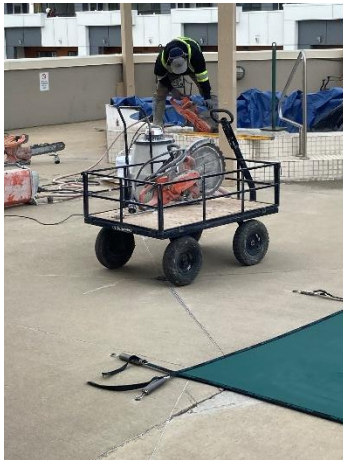
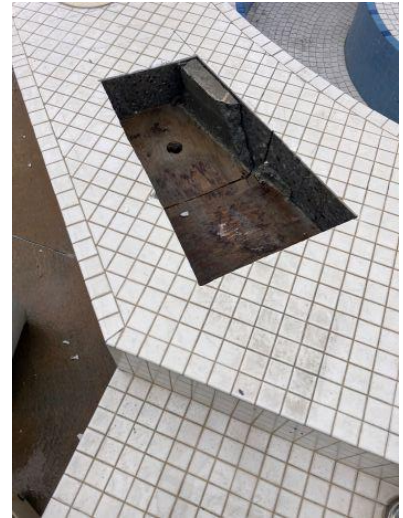
In the meantime, our pool contractor was able to get a radar scan (Precision Cutting and Coring) done on the upright hot tub wall and we opened the top section of the double wall up to see if we could find a leak or check to see how the lines were run, or how the walls were constructed.

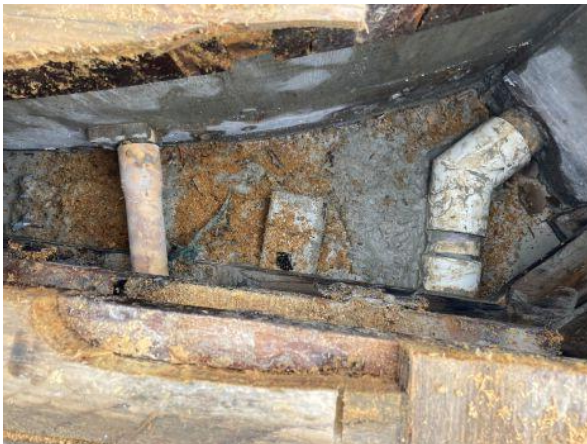
Our pool contractor with the top section open has located two lines, one line is the scrubber line which when tested did not leak. There was also one jet line in the cavity, but it was concrete, and when the jets are turned on it sprays water out the side of the hot tub bottom step (but not from the visible line).

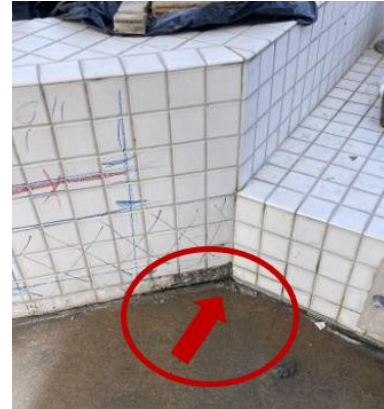
Our pool contractor cut the jet line and used a scope camera to try locating the leak with the amount of cable he ran out it appears the cracked line may be slightly below the structural suspended concrete deck which the structural engineer will not allow cuts in the deck. A further challenge is the bottom of our hot tub is concealed in the ceiling of a commercial tenant and not visible.

The structural engineer will review and guide strata on the next steps as to how we can access the problematic pipe that is below the structural slab somewhere to the left of the red arrow.

On the advice of KO Structural Engineer, our pool contractor is currently working to get a more in-depth radar scan done to accurately locate the structural beams supporting the hot tub.

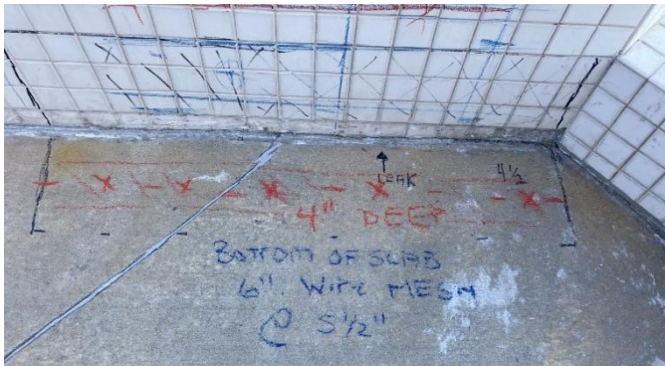
Precision Radar Scan was on site and scanned the area that our engineer (KO Structural Engineer) and our pool contractor (Poolman - All Service Properties) requested. As Poolman used a scope camera and noted the pipe with the leak is 4 1/2" below the pool deck.

Precision Radar scan revealed there is a 6" reinforced slab with welded wire mesh about 5 1/2" below the slab. This concrete rests directly on the 10" reinforced 2-way suspended slab supported by concrete beams. A scan report was received from Precision Radar Scanning, and he made notes directly on the slab near the leak as shown below.

Our pool contractor (Poolman) has been contacted to connect with Precision to cut open the slab area to expose the leak.

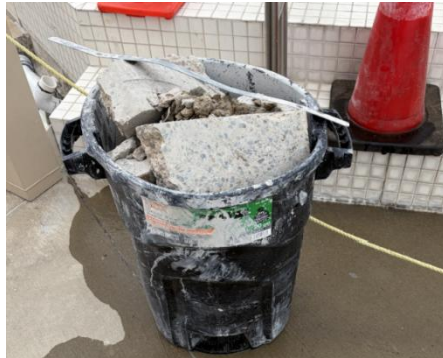
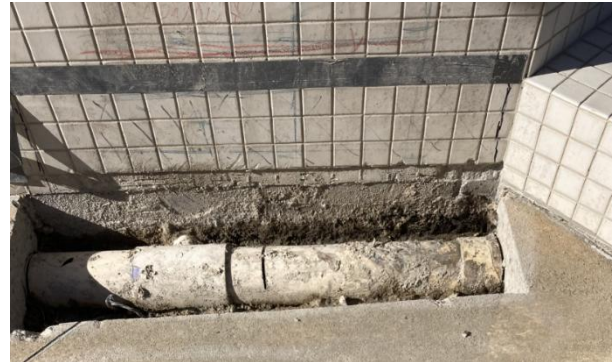
After the structural engineer sign-off the concrete slab was cut open by Precision Cutting and Coring. Ron the Poolman identified the leak on the right side of the cut.

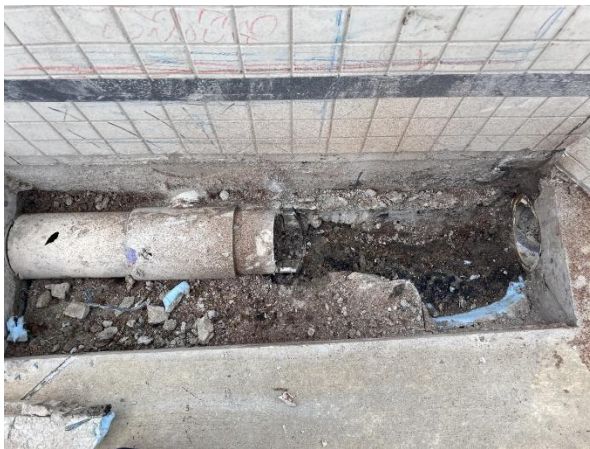
After the leak was identified the damaged piece was removed and a plumbing repair made.

Ron our pool contractor repaired the pipe and after the repair had time to set, the hot tub was filled with water and the system was evaluated.

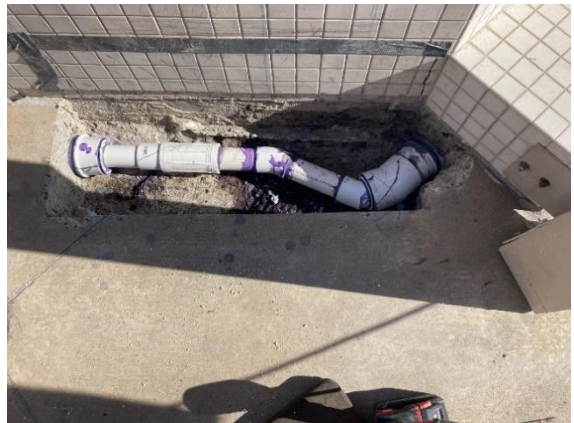
The jets were turned-on briefly, and no leaks were visible in the repaired section. Water levels were monitored and it was noted that water was leaking from other areas (see levels over 3 days) indicating a leak

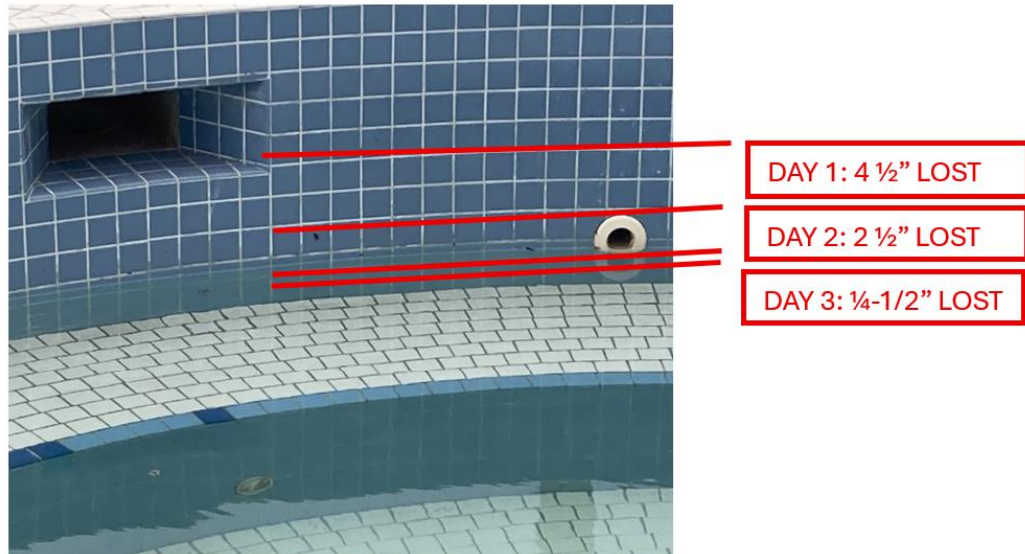
Hot Tub was filled with water, and levels were monitored and it was noted that water was leaking from other areas (see levels over 3 days) indicating a leak

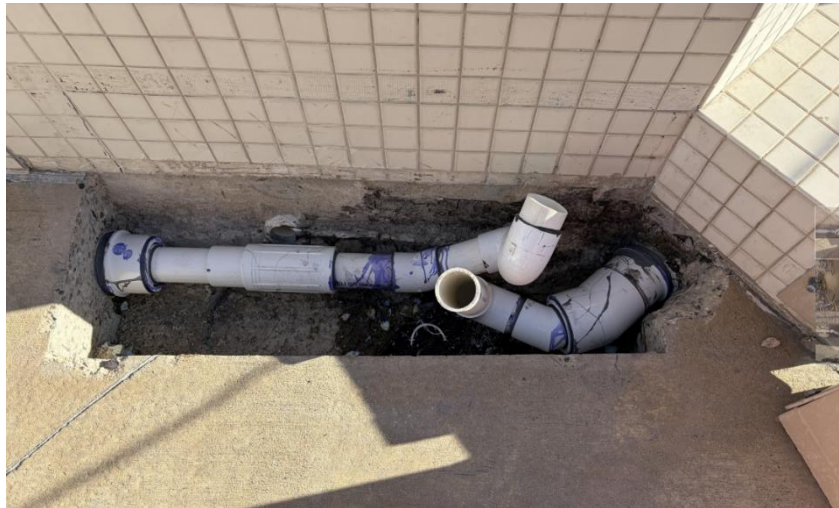
The fixed plumbing area had to be opened up, and camera was used to investigate another possible leak.

Another leak was identified on other side of steps to hot tub.

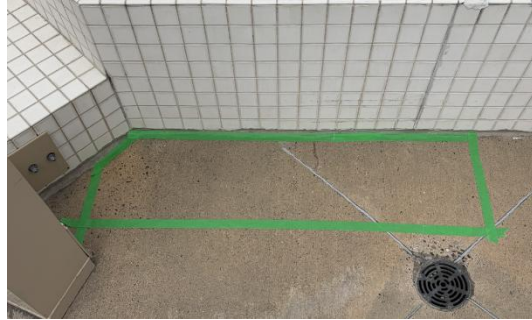
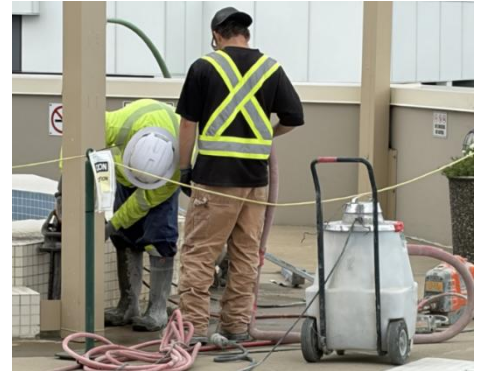
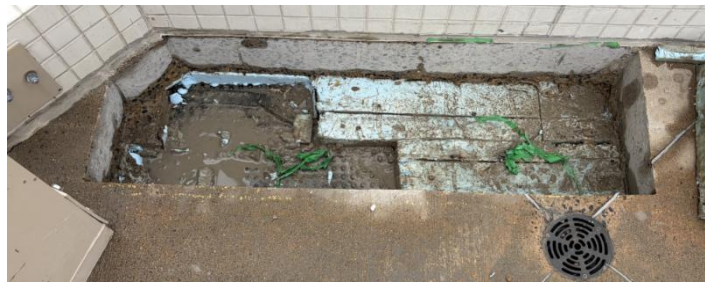
Our pool contractor (Ron the Poolman) arranged for Precision Cutting and Coring to cut open another around to the right of the hot tub stairs to expose pipes. The area identified was cut open.

As the jet supply pipe was not located additional investigation with camera was undertaken and strategy generated.

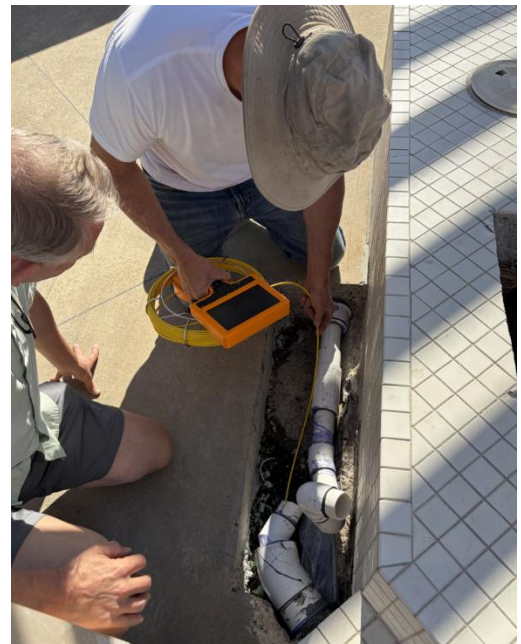
Additional camera scope work identified a crack near the end of the hot tub stair, and it was decided to cut open the top of the hot tub and if need be when area was exposed stair may have to be cut.

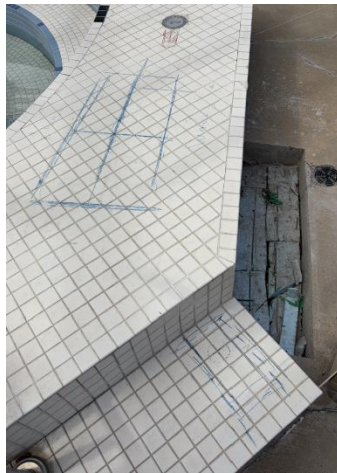
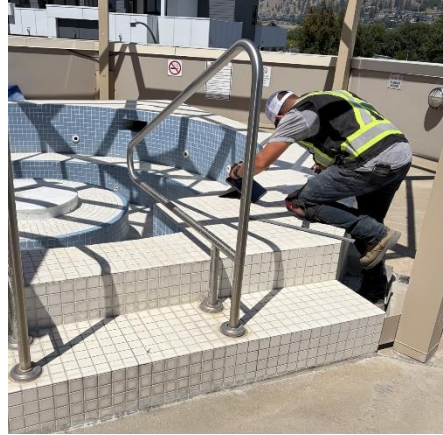
The top of the Hot Tub outlined the concrete walls below and the location of the electrical box and conduit. Electrical appeared not to be in the way of the cut outlined at the top of the Hot Tub.

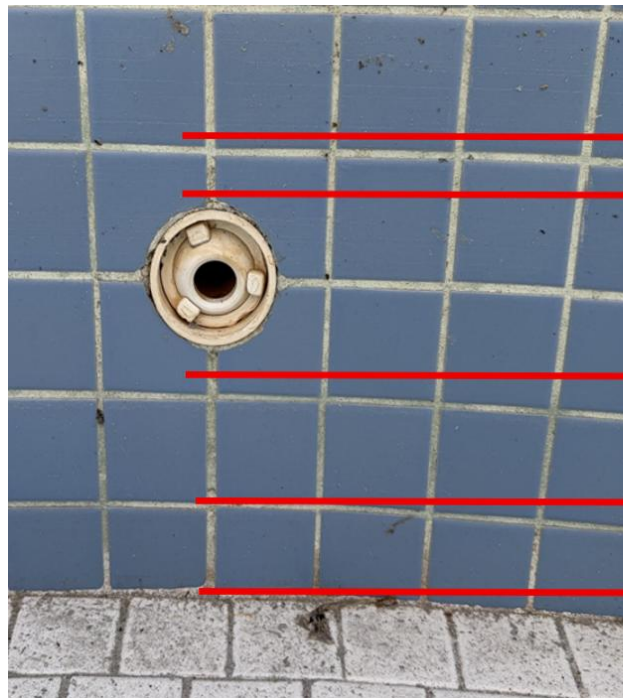
Water level in the Hot Tub was monitored over a 5 day period with the following results.

Tuesday 8" Water  
Level Fill

Wednesday 7"

Thursday 4 ½"

Friday 2"

Saturday 1"

Sunday 0" Empty

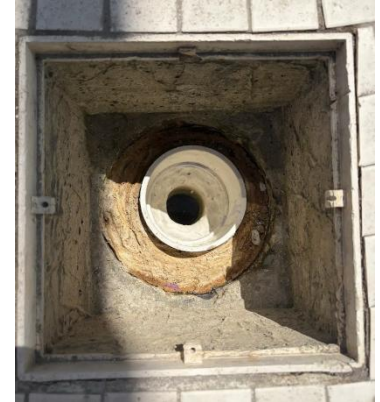
Ron (Poolman) feels there is a small leak in one of the three drains. A dye was used to detect a leak in the drain with the lowest water level. The leak was sealed as shown to the right.

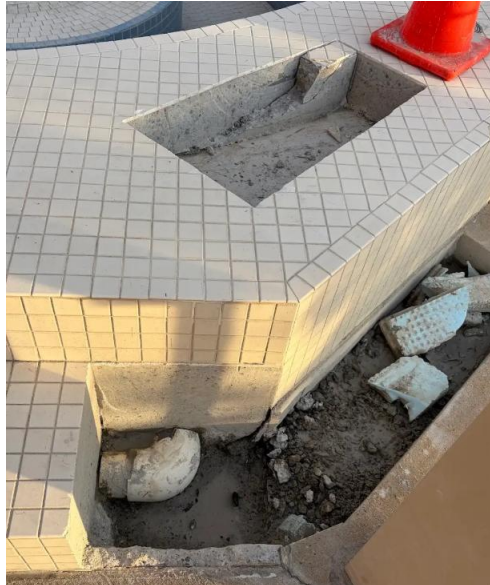
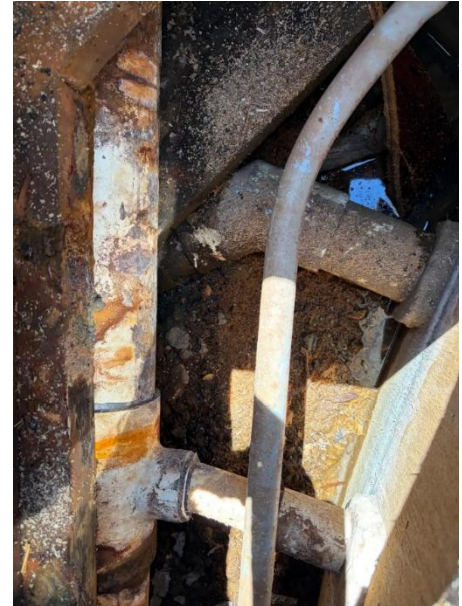
The two areas were exposed that require access. The area of concern was the pipe under the slab to the right of the stairs as shown below. A crack was identified in the elbow.

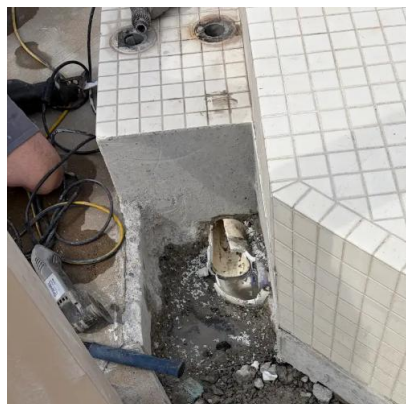
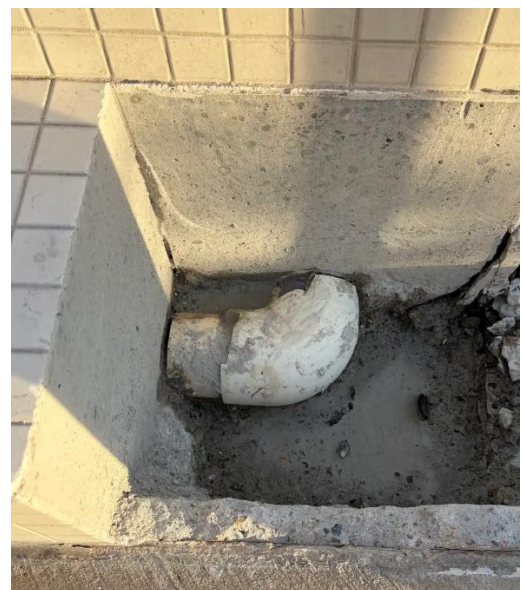
The top of the Hot Tub wall was exposed and conduit, jet piping and drain system was exposed.

The other area of concern is the jet supply elbow section with a crack was exposed and illustrated below.

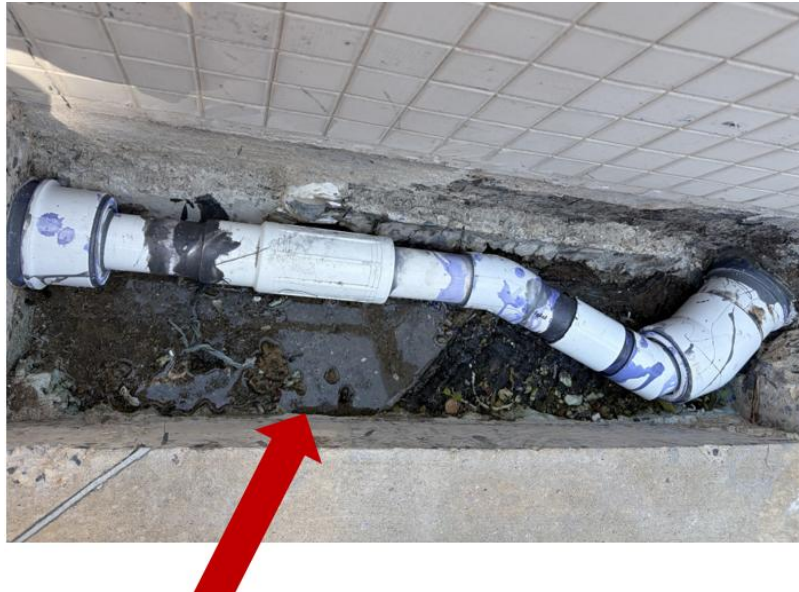
After the jets were turned on water was detected in the area to the left of the stairs. The plumbing fixes were not leaking but water was seen coming from under the fabric likely from somewhere between the left and right side of stairs.

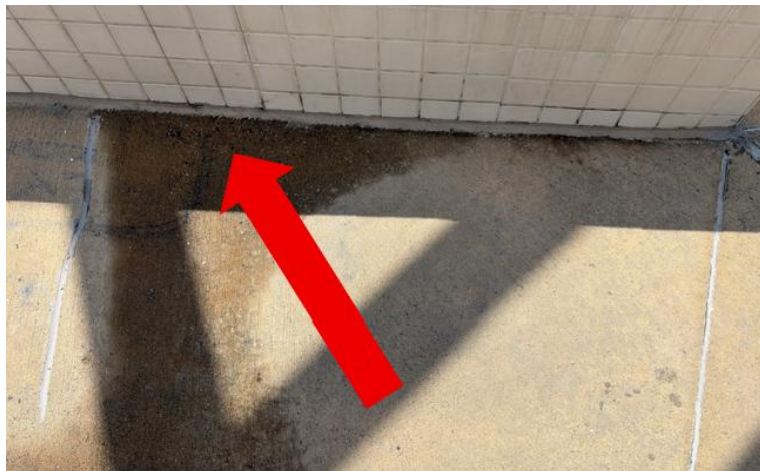
The northwest corner of the Hot Tub revealed another area of potential leak which is an elbow located by Precision Scanning last visit.. Our pool contractor Ron stated he would contact Prerecession Cutting and Coring to cut open another concrete area.

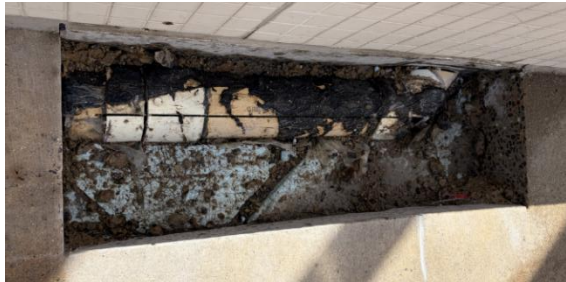
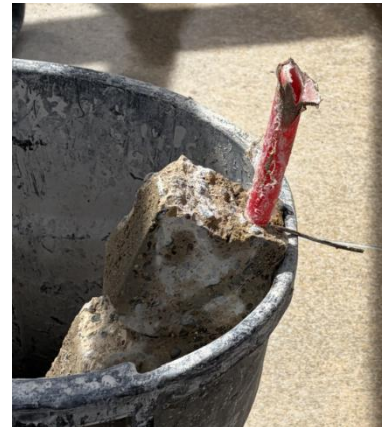
Concrete slab and unfortunately the glycol line was accidentally in the process and will have to be repaired.

Below the jet pipe was exposed.

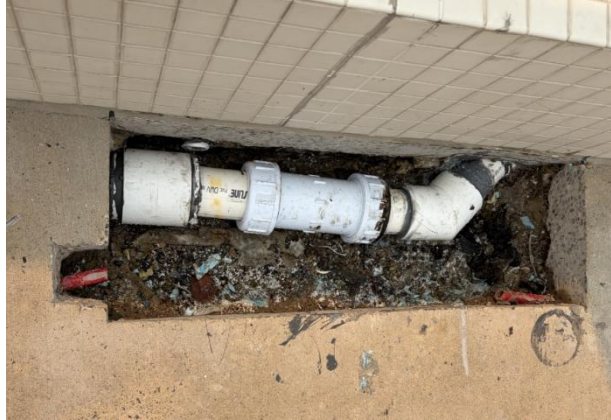
Compression fitting on the 3<sup>rd</sup> leak was failing and it was decided that a better option consisting of a glued connection was needed. This was a special order from Untied States.

Our pool contractor (Ron Poolman) completed jet pipe fix on the 3<sup>rd</sup> leak area with a compression fitting.

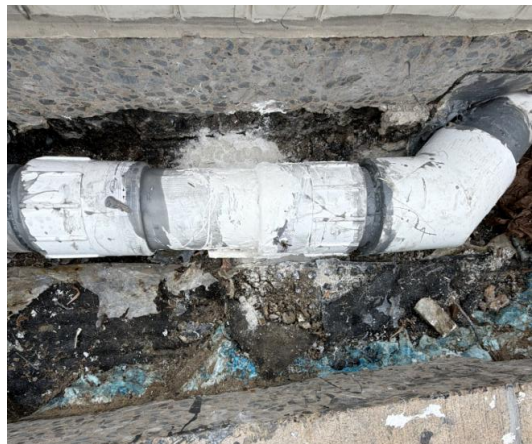
Minimum loss of water was experienced, and all connections showed no leaks or moisture.

Special fittings arrived and were installed with epoxy and a secondary fitting applied for best possible solution.

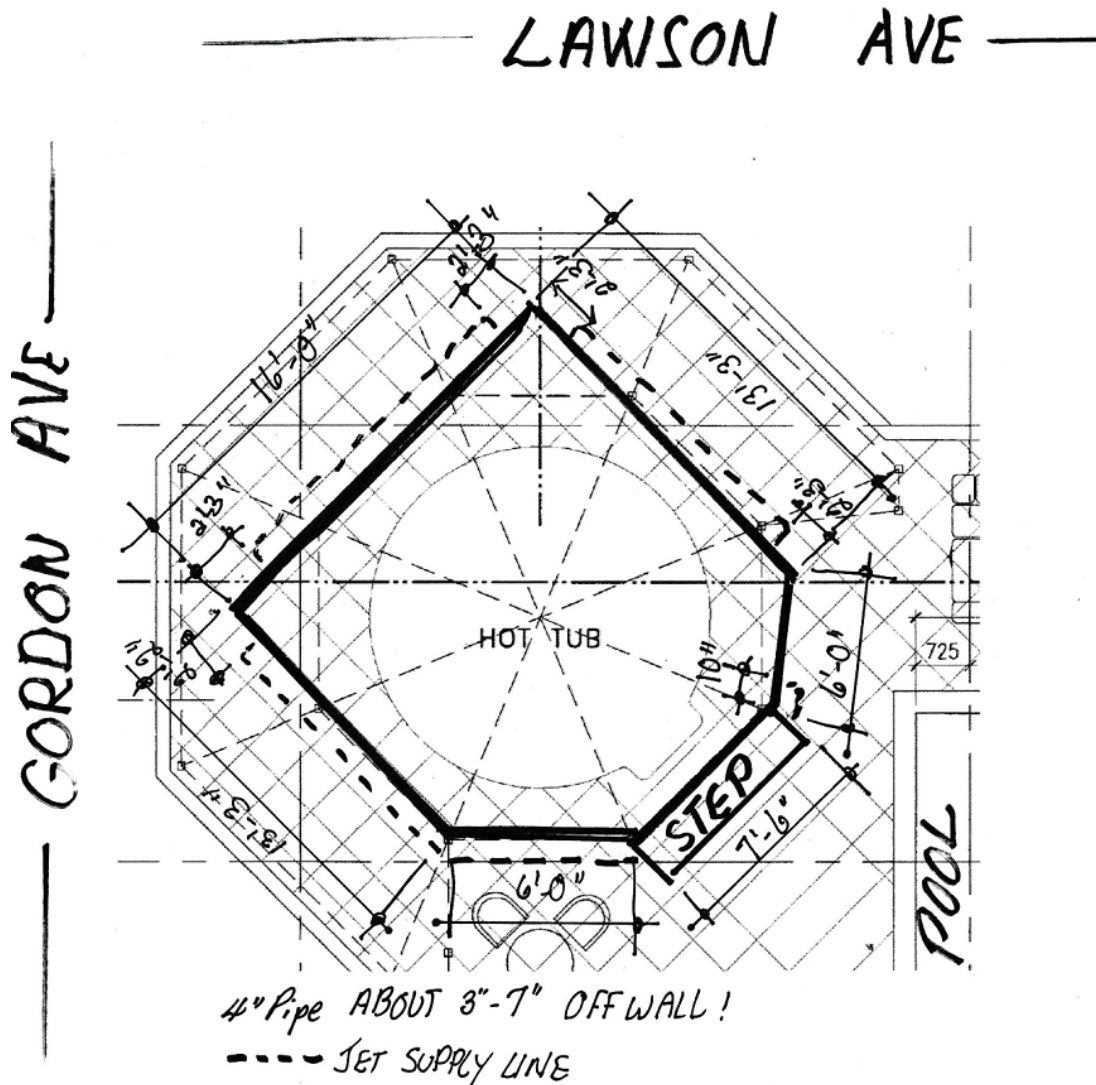
### LOCATION of PLUMBING in POOL DECK SLAB (From Scan)

For future reference the following sketch indicates where pipe for jets is located under the slab.
