Hot Tub at Centuria Urban Village developed a leak. The Hot Tub was immediately closed and below is a summary as well as the latest findings as we have worked on a fix. A summary of events in a timeline format is presented below.

**HOT TUB REPAIR**

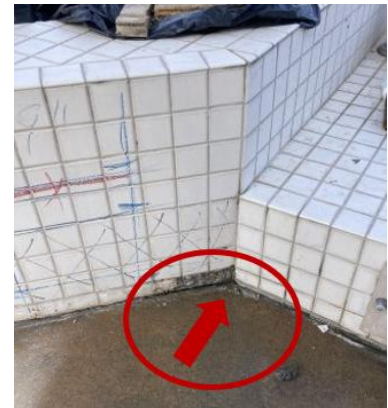
After the leak seal product was applied and adequate time to setup the jets were re-tested, but a large leak persisted near the pool deck as shown above (red arrow).

It was recommended that the top of the concrete area above the jets be cut open to investigate. Issues with getting the location of the leak pinpointed and what is required to repair were as follows:

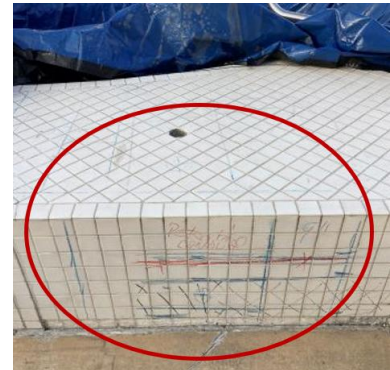
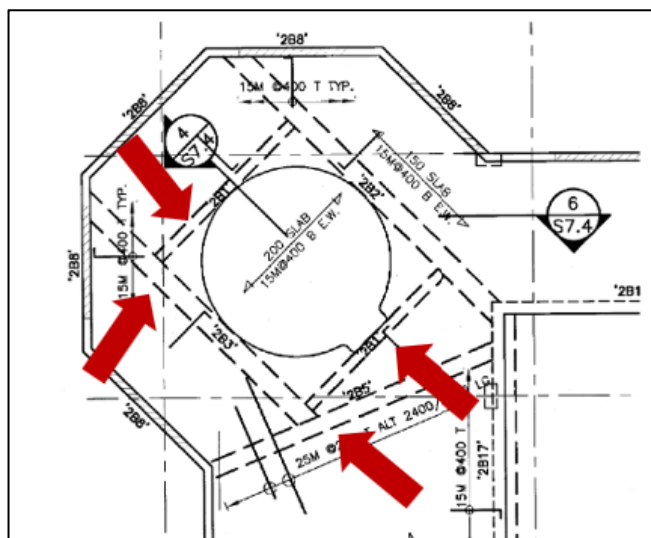
Once KO Structural reviewed the drawings and another site visit they required a scan report to be done to determine where the support beams were and the size of the beams, and rebar in the concrete as shown in the diagram below.

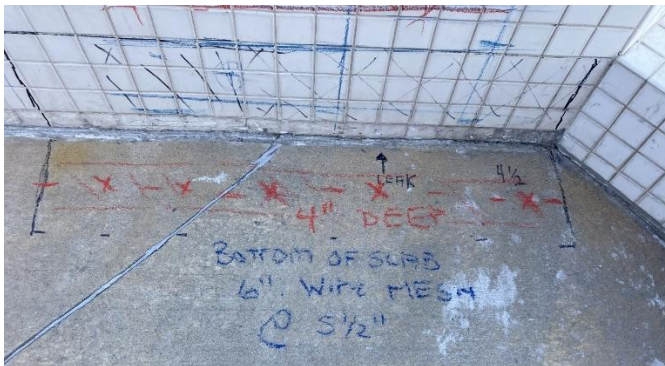
Precision Radar Scan was on site and scanned the area that our engineer (KO Structural Engineer) and our pool contractor (Poolman - All Service Properties) requested. As Poolman used a scope camera and noted the pipe with the leak is 4 ½" below the pool deck.

Precision Radar scan revealed there is a 6" reinforced slab with welded wire mesh about 5 ½" below the slab. This concrete rests directly on the 10" reinforced 2-way suspended slab supported by concrete beams. A scan report was received from Precision Radar Scanning, and he made notes directly on the slab near the leak as shown below.

Our pool contractor (Poolman) has been contacted to connect with Precision to cut open the slab area to expose the leak.

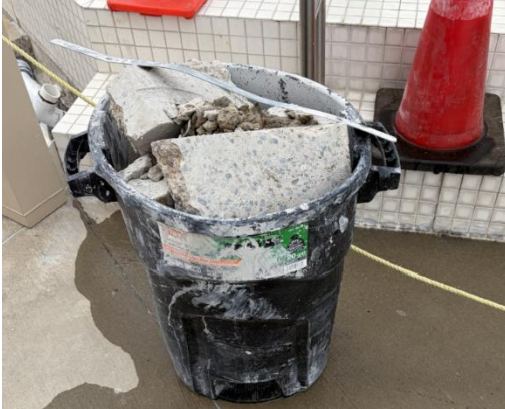
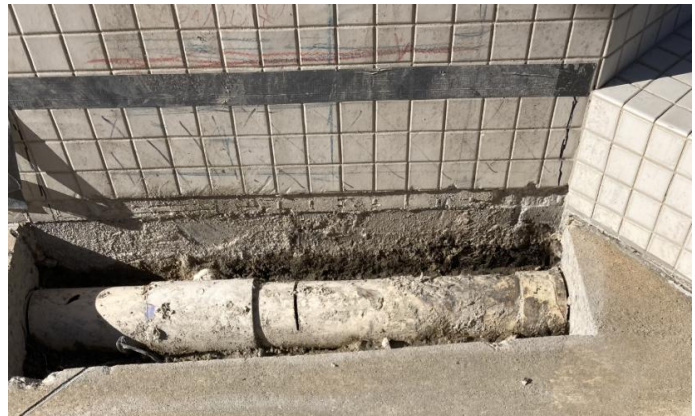
After the structural engineer sign-off the concrete slab was cut open by Precision Cutting and Coring. Ron the Poolman identified the leak on the right side of the cut.

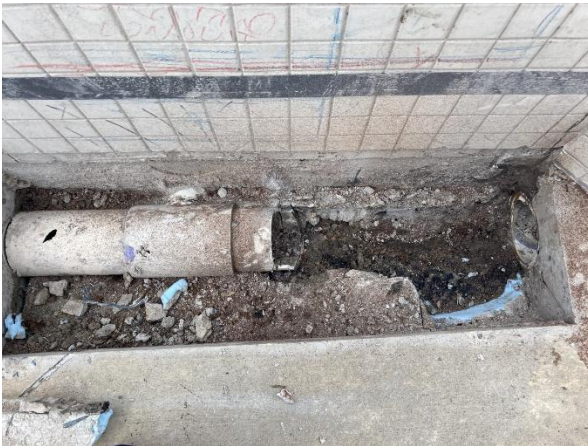
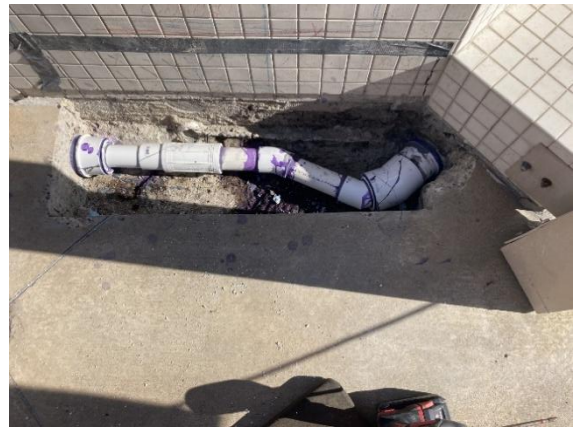
After the leak was identified the damaged piece was removed and a plumbing repair made.

Ron our pool contractor repaired the pipe and after the repair had time to set, the hot tub was filled with water and the system was evaluated. The jets were turned-on briefly, and no leaks were visible in the repaired section. Water levels were monitored and it was noted that water was leaking from other areas (see levels over 3 days) indicating a leak

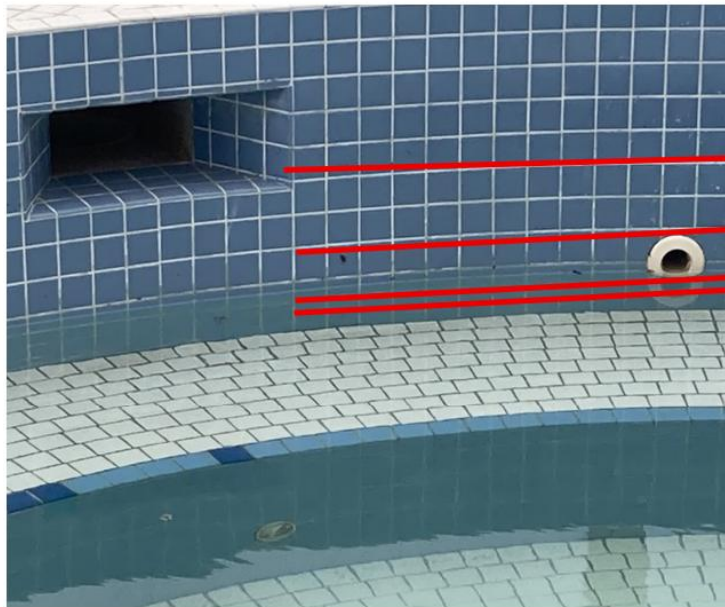
Hot Tub was filled with water, and levels were monitored and it was noted that water was leaking from other areas (see levels over 3 days) indicating a leak

DAY 1: 4 ½" LOST

DAY 2: 2 ½" LOST

DAY 3: ¼-1/2" LOST

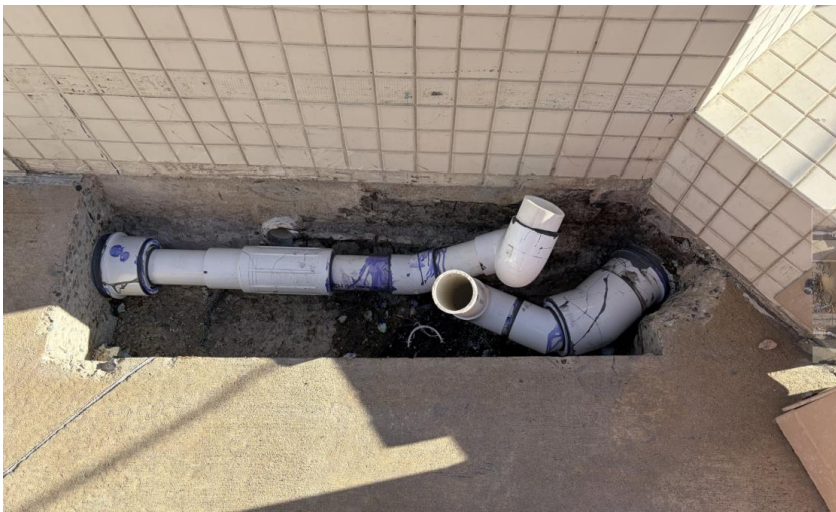
The fixed plumbing area had to be opened up, and camera was used to investigate another possible leak.

Another leak was identified on other side of steps to hot tub.

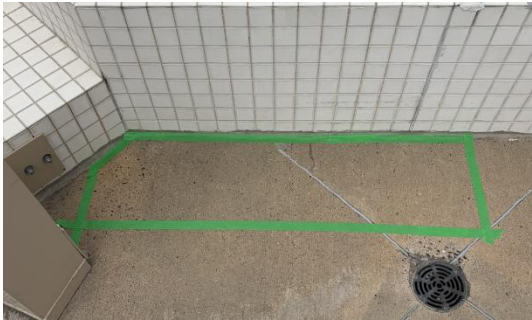
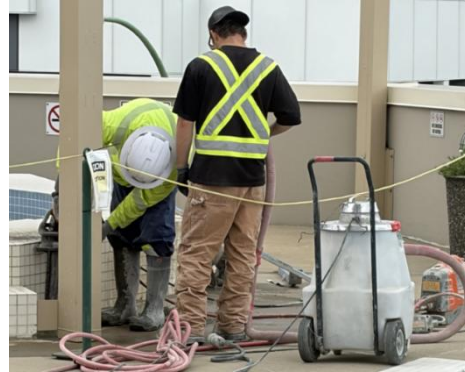
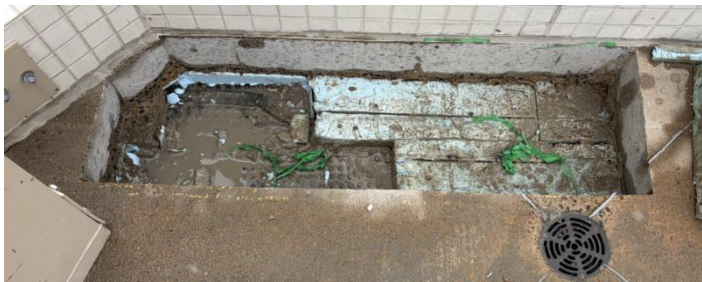
Our pool contractor (Ron the Poolman) arranged for Precision Cutting and Coring to cut open another around to the right of the hot tub stairs to expose pipes. The area identified was cut open.

As the jet supply pipe was not located additional investigation with camera was undertaken and strategy generated.

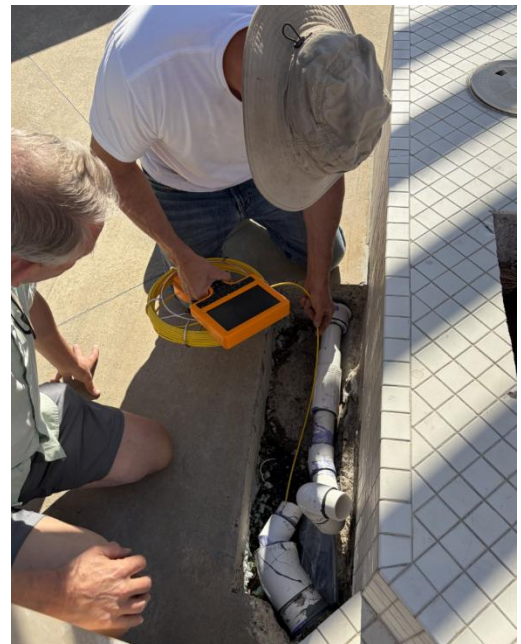
Additional camera scope work identified a crack near the end of the hot tub stair, and it was decided to cut open the top of the hot tub and if need be when area was exposed stair may have to be cut.

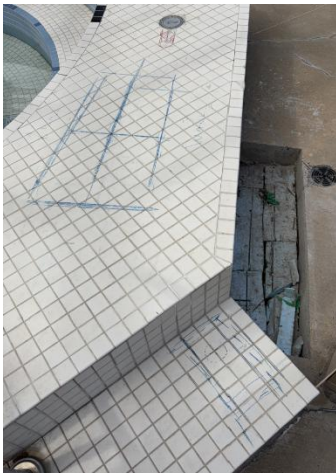
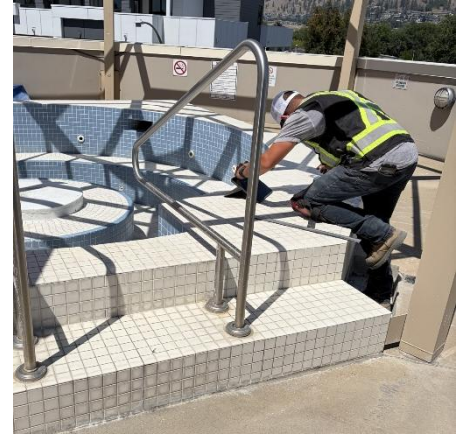
Jason from Precision Scanning was on site scanning the top of the Hot Tub as well as the perimeter to locate jet line.

The top of the Hot Tub outlined the concrete walls below and the location of the electrical box and conduit. Electrical appeared not to be in the way of the cut outlined at the top of the Hot Tub.

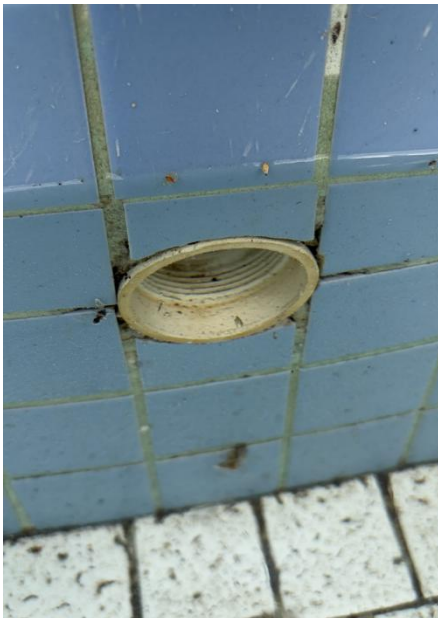
Before leaving our pool contractor Ron filled the Hot Tub with 8" of water and this will be checked tomorrow to see if any additional water leaked. Ron noted before filling Hot Tub there was water in the bottom drains.

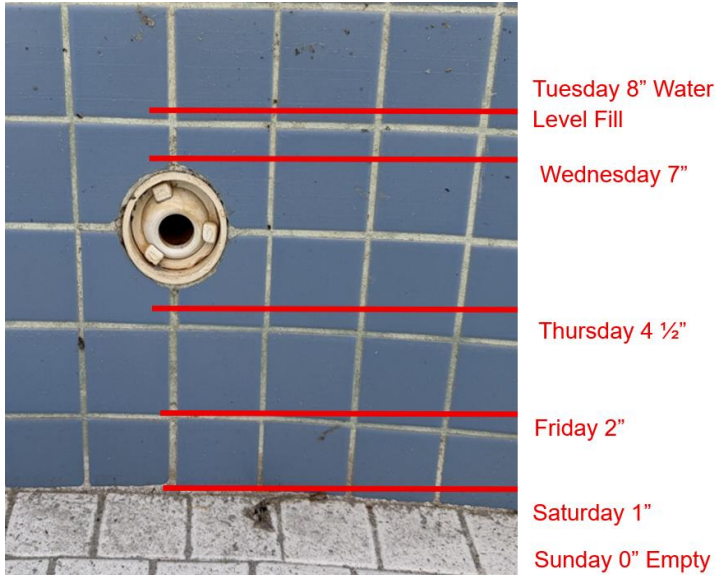
Water level in the Hot Tub was monitored over 5 day with the following results.
