Hot Tub at Centuria Urban Village developed a leak. The Hot Tub was immediately closed and below is a summary as well as the latest findings as we have worked on a fix. A summary of events in a timeline format is presented below.

**Timeline Summary:**

**Hot Tub Repair Cost / Budget:**

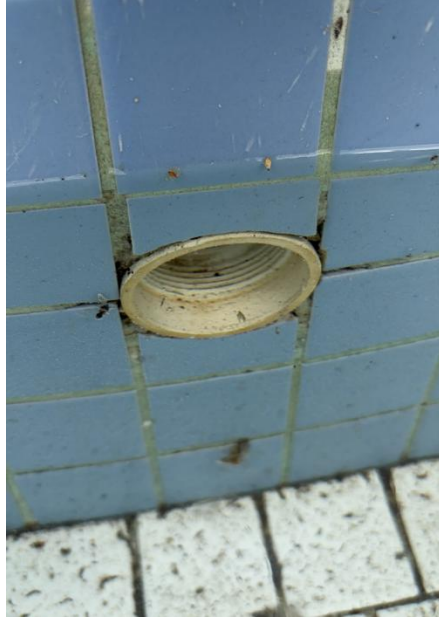
Before leaving our pool contractor Ron filled the Hot Tub with 8" of water and this will be checked tomorrow to see if any additional water leaked. Ron noted before filling Hot Tub there was water in the bottom drains.

Water level in the Hot Tub was monitored over a 5 day period with the following results.

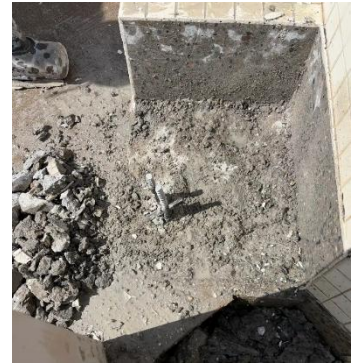
Precision Cutting and Coring with Ron (Poolman) were on site to cut 2 areas of the Hot Tub including to the right of the stairs and the top above the area to the right of the stairs

To the right is a graphic of Precision Coring and Cutting as they cut the stairs and the top of the Hot Tub.

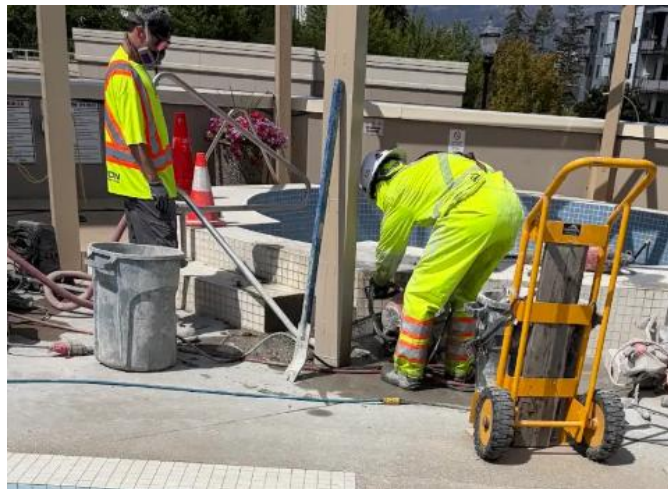
Below Precision Cutting and Coring continues with the work to exposed problem areas..

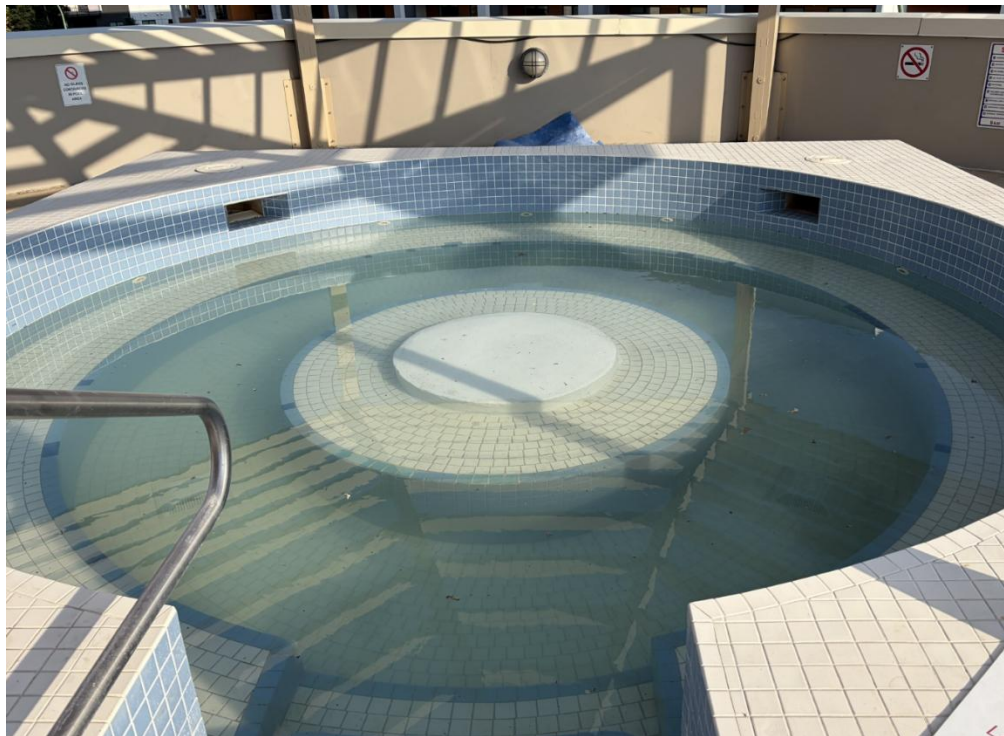
After plumbing joints were allowed to set-up Hot Tub was filled with water.

After the jets were turned on water was detected in the area to the left of the stairs. The plumbing fixes were not leaking but water was seen coming from under the fabric likely from somewhere between the left and right side of stairs.

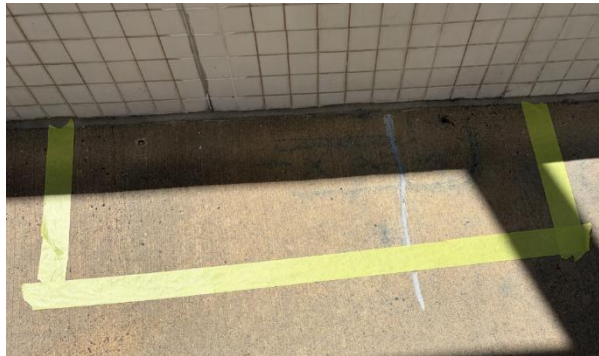
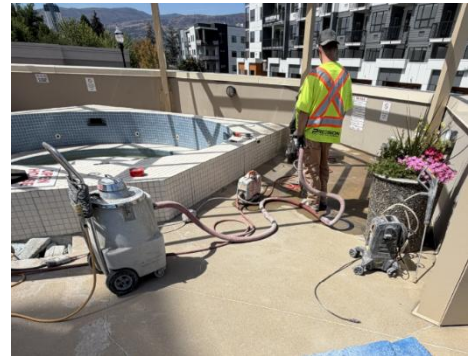
Precision Cutting and Coring was onsite at centuria at 12:30pm to make another cut into the slab as another leak was indicated. Our pool contractor laid out the area to be cut for the Precision Cutting and Coring crew.

Concrete slab and unfortunately the glycol line was accidentally in the process and will have to be repaired.

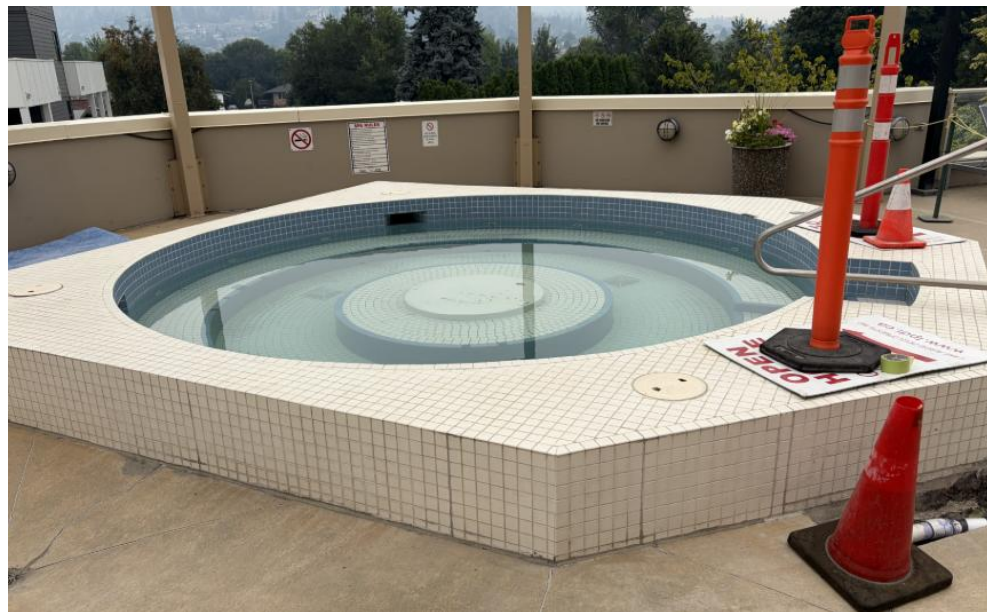
Hot Tub was drained, cleaned, and filled with water. Next repair areas were monitored for any leaks.

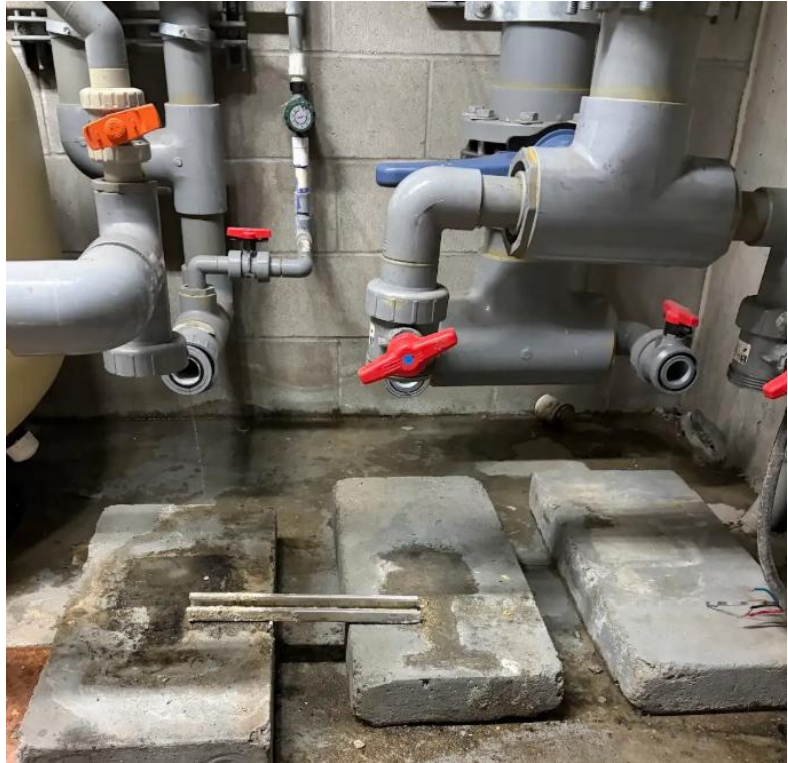
It was decided at this time to remove the 3 pumps that serviced the hot tub and replace seals to ensure future use.

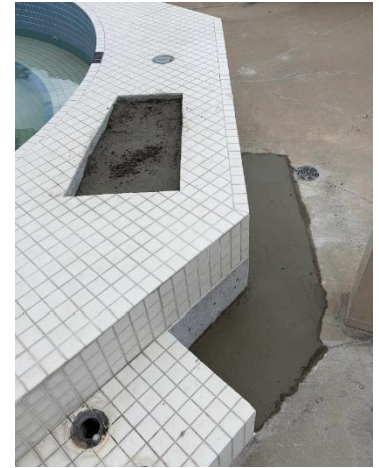
Concrete repairs were underway for the areas on the concrete slab. Holes in the top of the hot tub wall were addressed as they needed to be supported and areas filled with concrete.

Once set up white epoxy finish to be applied.

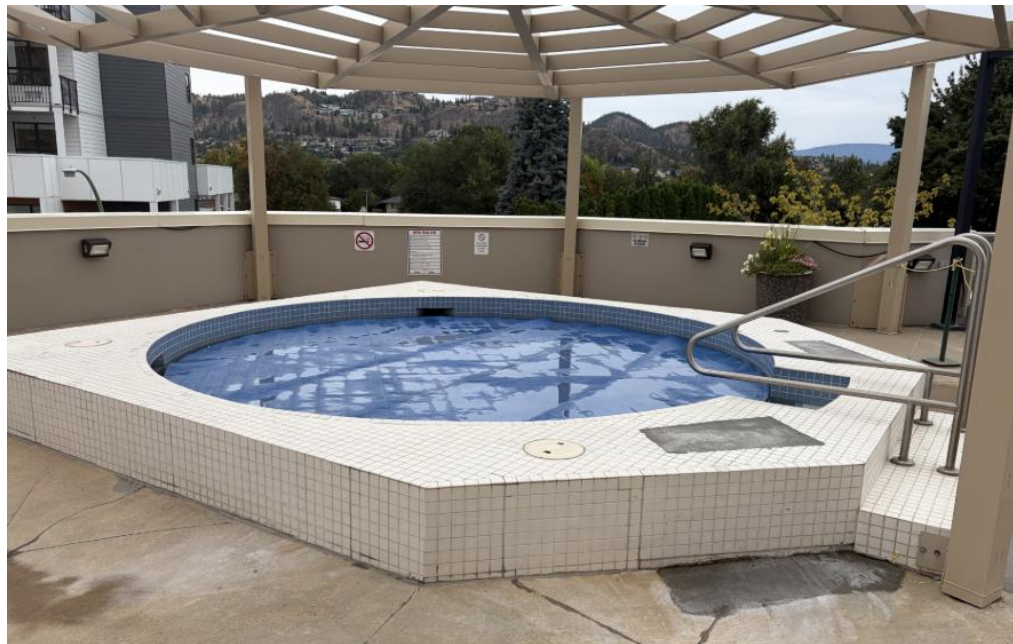
Circulating pump was run and heaters turned on to further test the hot tub. No leaks were identified. Hot tub covers was placed over hot tub.
